Subject: **Annual (2017) CCR Impoundment Inspection Report**
Economizer Ash Pond System – FDEP#20
Tampa Electric Company
Big Bend Power Station
Apollo Beach, FL
AREHNA Project No. B-15-073

Economizer System Earthen Berm Inspection
TECO Big Bend, FL
AREHNA Project No. B-15-073

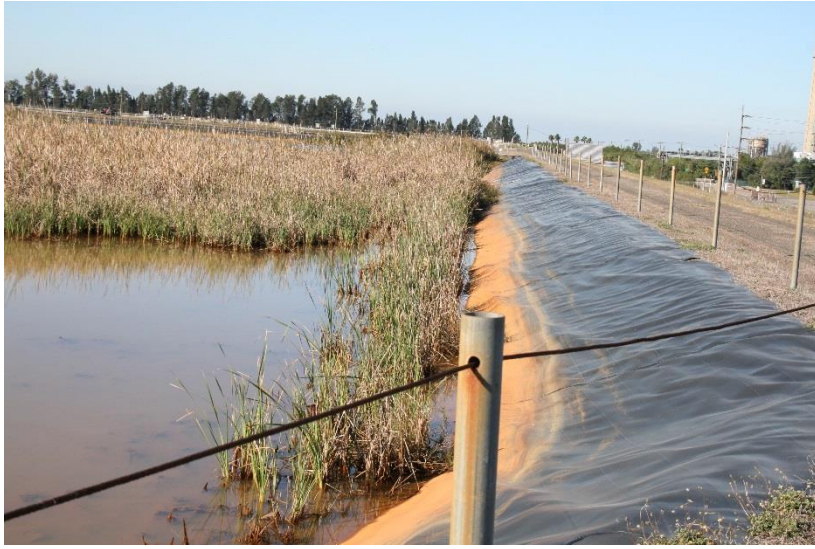
North Economizer Ash Pond (north side, looking west)

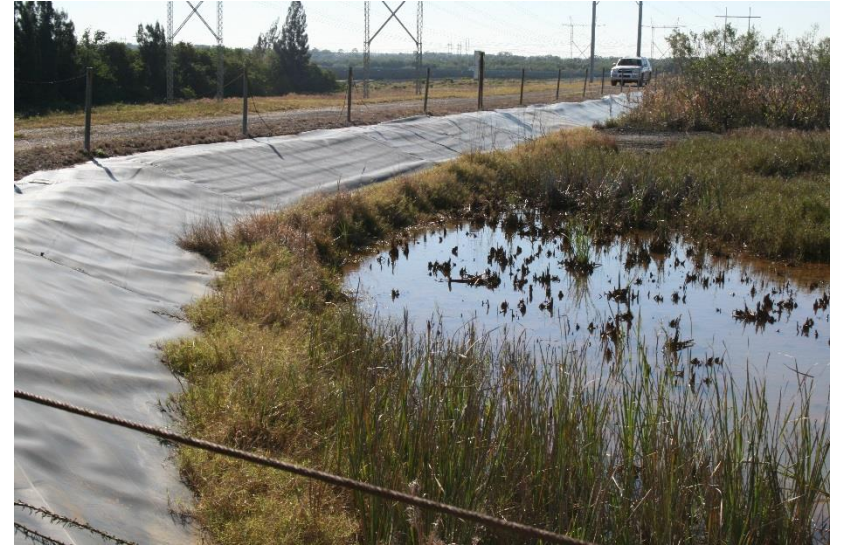
North Economizer Ash Pond (east side, looking south)

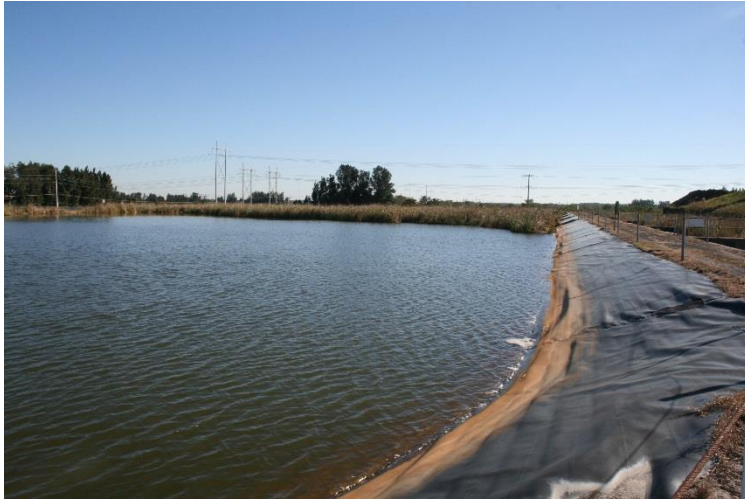
North Economizer Ash Pond
(south side, looking east)

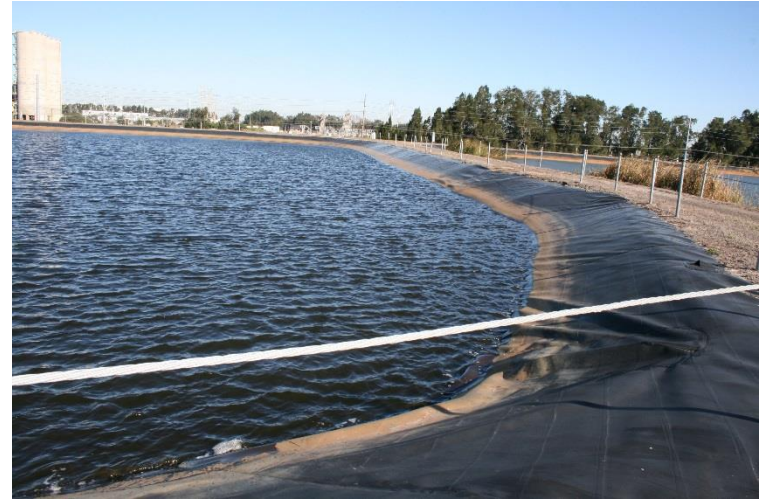
Economizer Ash Suction Pond
(east side, looking northeast)

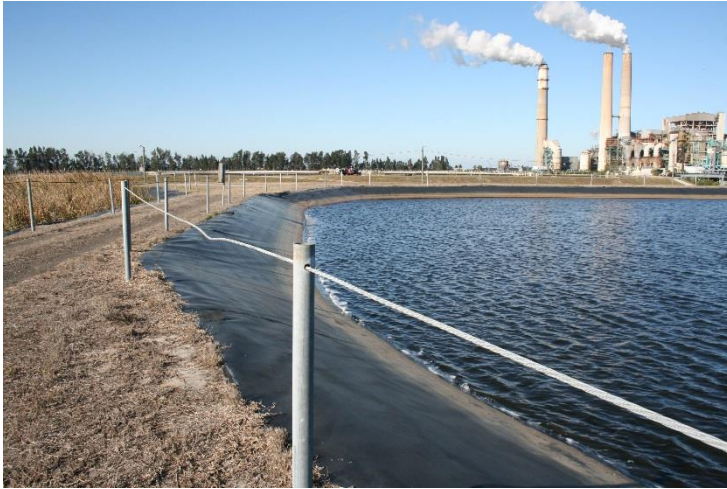
Economizer Ash Suction Pond
(south side, looking west)

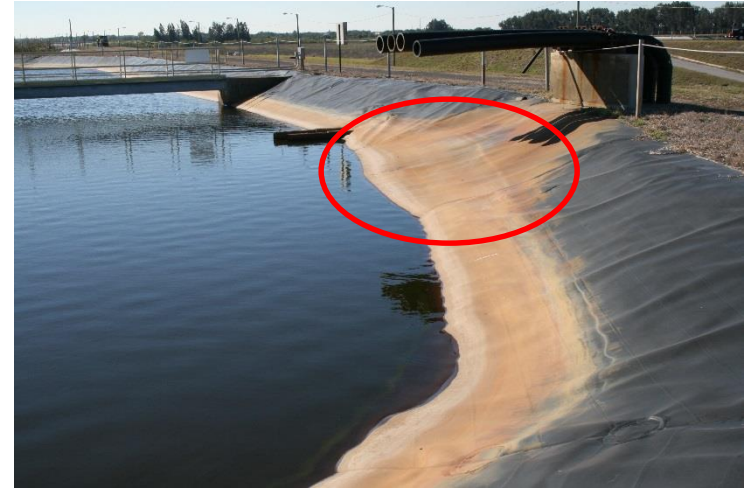
- The lined inside north-slope of the Economizer Ash Suction Pond has an inconsistent slope surface that also resembles a bulge. The water level in the suction pond should be lowered and this area further inspected.
- There is a small bulge in the liner beneath the central pipe that drains water from the South Economizer Ash Pond to the Long Term Fly Ash Pond. The reason for the bulge is not readily apparent. Since the bulge is directly below a drainage pipe, we recommend that this area be further inspected.

Economizer Ash Suction Pond
(west side, looking south
at irregular liner surface)

Although these areas of concern should be further investigated, the system is currently no longer receiving CCRs and will be dewatered and demolished within the next three years to comply with the rule as detailed at the beginning of this report.

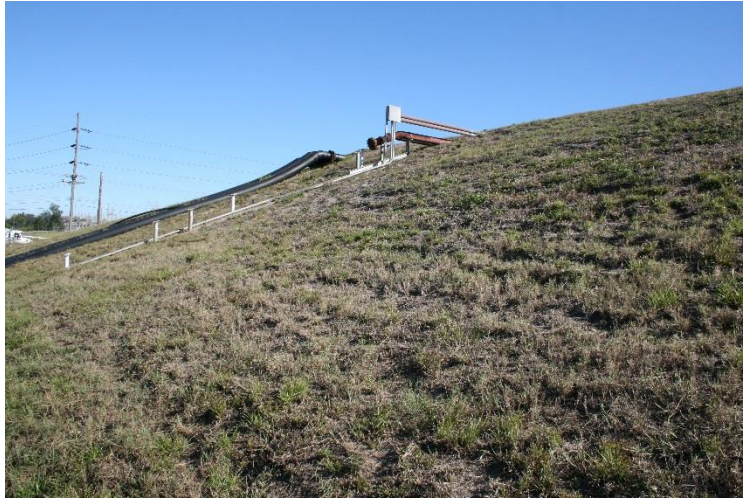
Economizer Ash Suction Pond
(west side, looking east
at embankment penetrations)

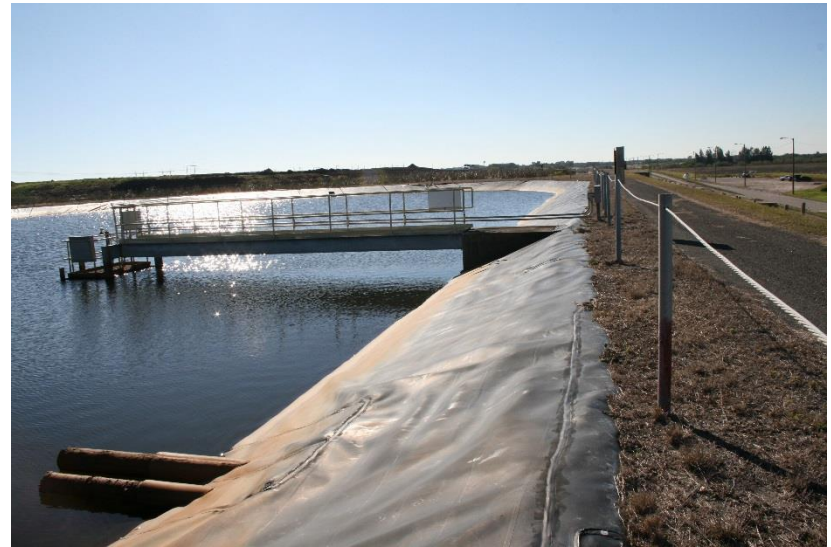
Economizer Ash Suction Pond
(west side, looking south
at instrumentation platform)

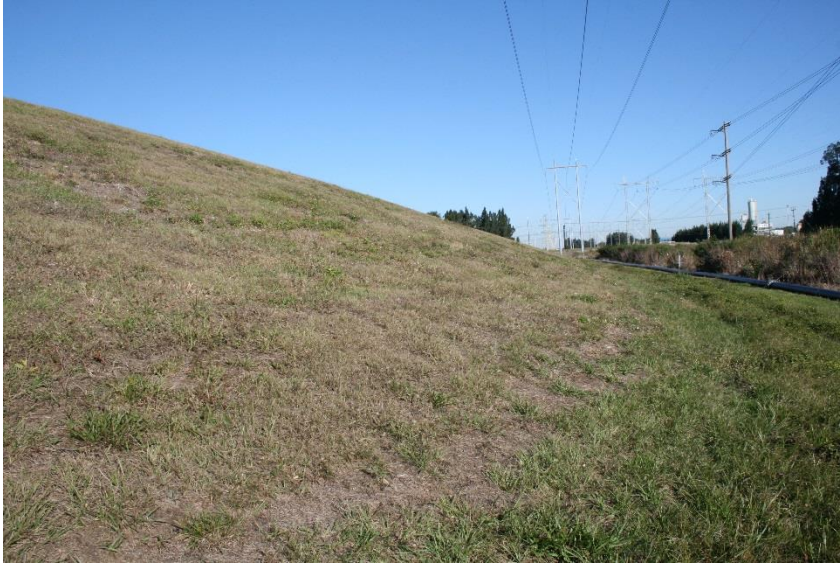
South Economizer Ash Pond
(east side, looking north)

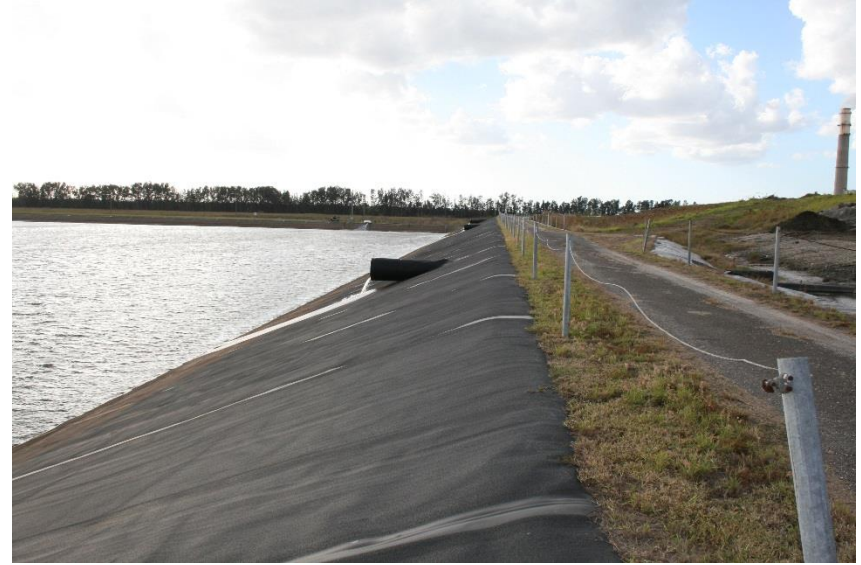
South Economizer Ash Pond
(south side, looking west)

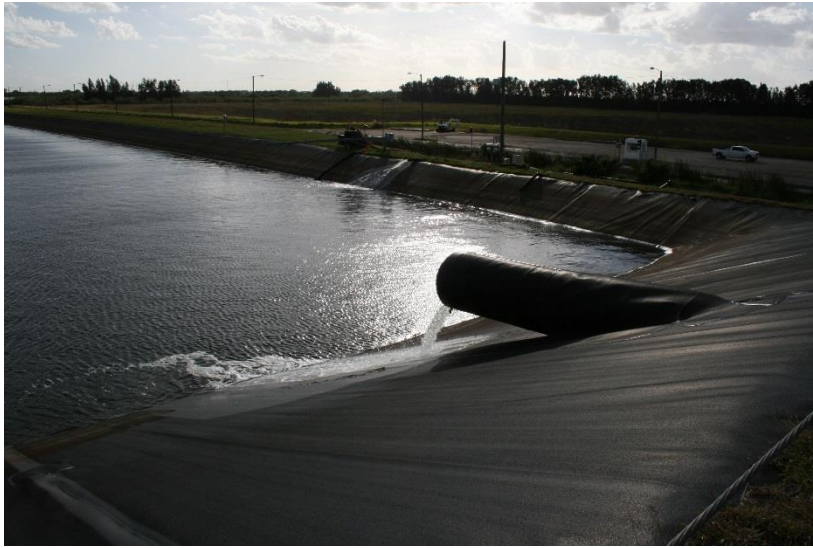
South Economizer Ash Pond
(south side, looking southwest
at bulge below central pipe discharging
into the Long Term Fly Ash Pond)

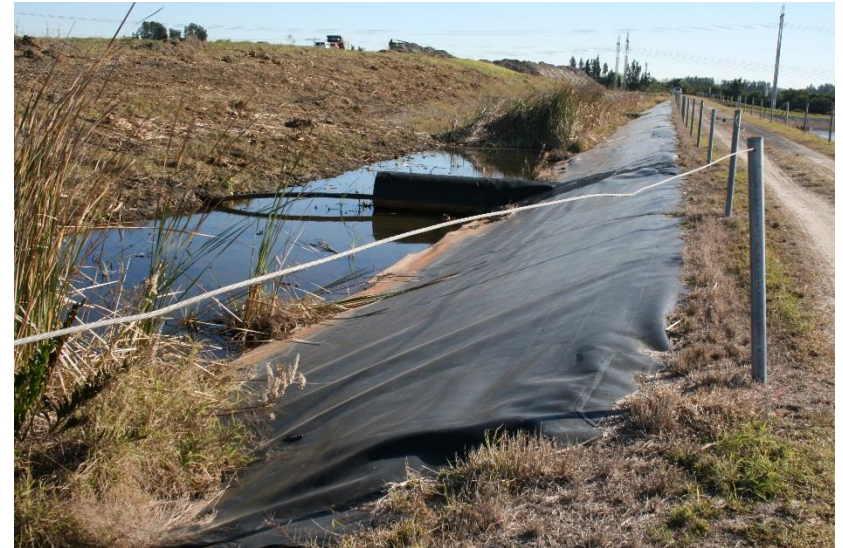
South Economizer Ash Pond
(south side, looking east)
