February 10, 2019

Subject:       **Annual (2018) CCR Impoundment Inspection Report**  
Economizer Ash Pond System – FDEP#20  
Tampa Electric Company  
Big Bend Power Station  
Apollo Beach, FL  
AREHNA Project No. B-15-073

Economizer System Earthen Berm Inspection  
TECO Big Bend, FL  
AREHNA Project No. B-15-073

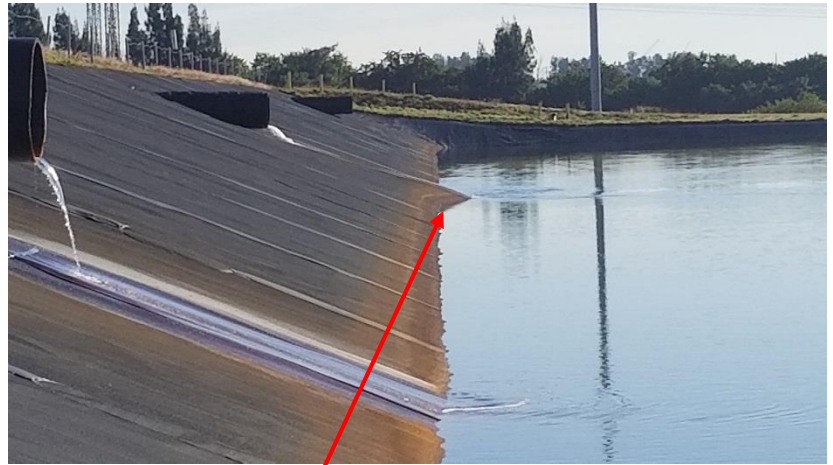
- There is a bulge in the liner beneath the central pipe that drains water from the South Economizer Ash Pond to the Long Term Fly Ash Pond. The reason for the bulge is not readily apparent. Since the bulge is directly below a drainage pipe, we recommend that this area be further inspected.

Bulge beneath pipe

Although this area of concern are noted for further investigated, the system is currently no longer receiving CCRs and will be dewatered and demolished within the next two years to comply with the rule as detailed at the beginning of this report.
